NBSIR 77-1314

Solar Energy Systems - Survey of Materials Performance

Final Report

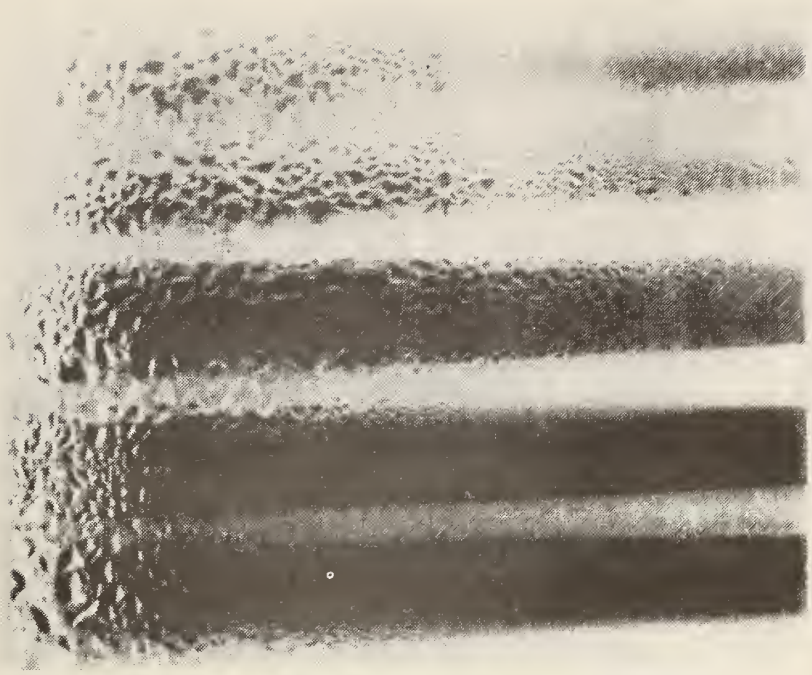
1. Condensation was observed on cover plates of 24 out of 25 systems inspected. The amount and degree of condensation appeared to depend on the time of day and the design of the collector (see fig. 2-1.) Condensation, such as that in figure 2-1, may affect the transmittance of the cover.

Figure 2-1. Condensation on Cover Plate Interior Surface

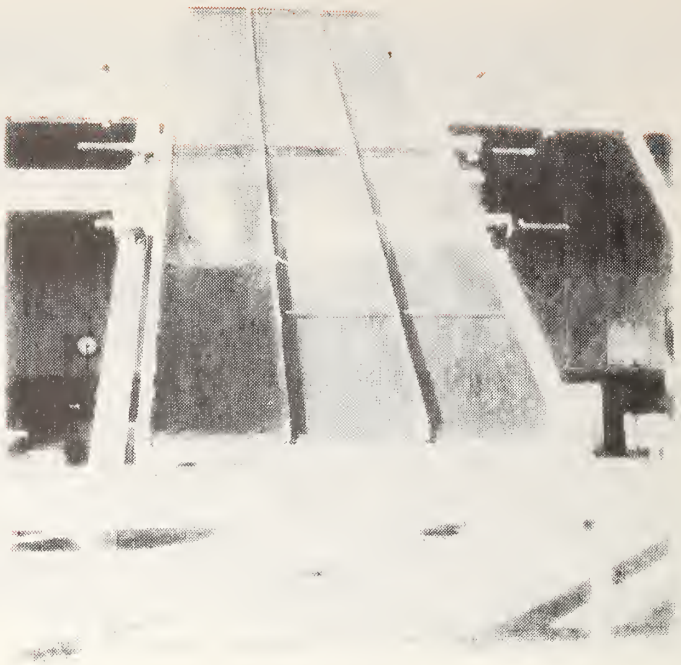
4. Outgassing of improperly cured silicone sealant was observed. The outgassing caused fogging of the cover plates (see fig. 2-3).

Figure 2-3. Fogging of Cover Plate Interior Surfaces Caused by Outgassing

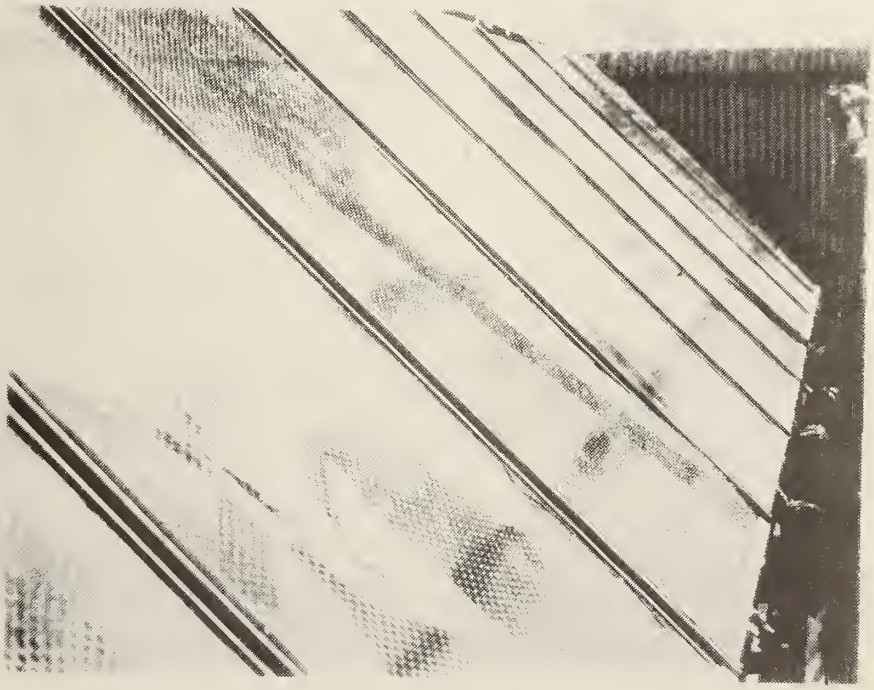
1. Glass cover plate breakage, ranging from none to approximately 90% in one system, was observed. The breakage that occurred in the system with 90% failure was a double cover system with both covers broken (see fig. 2-6.)

Figure 2-6. Extensive Breakage of Plate Glass Cover Plates

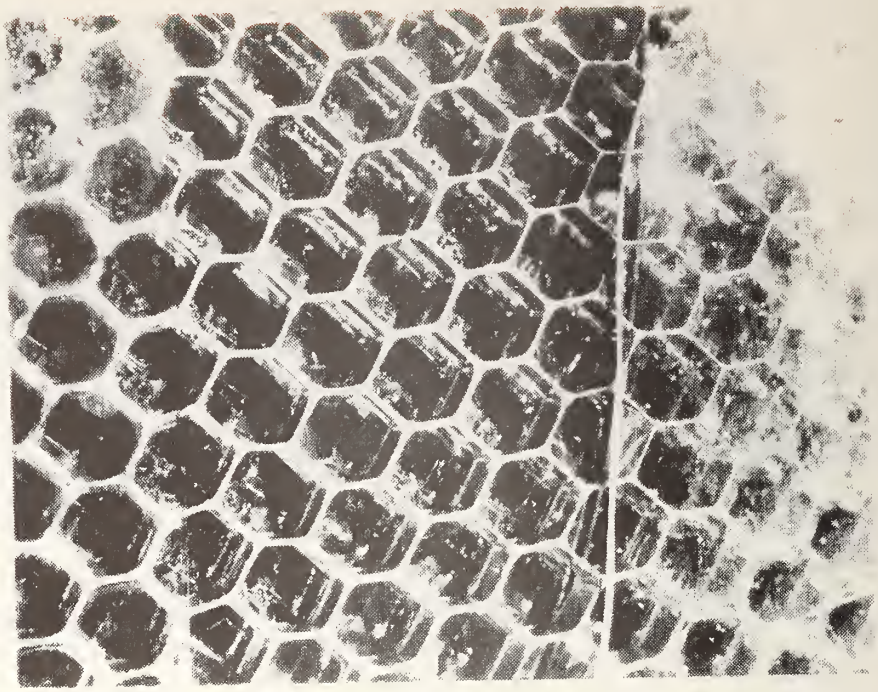
Figure 2-7. Adhesive Deterioration Which Resulted in Bond Failure Between Plate Glass Cover Plates and Aluminum Honeycomb Heat Trap

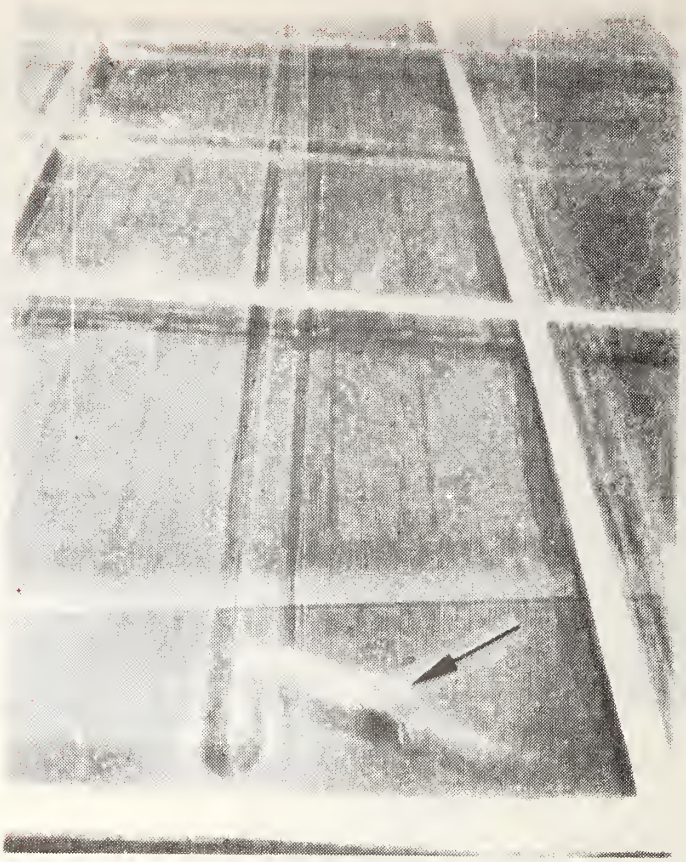
Figure 2-11. Incompatibility Between Polycarbonate Cover Plates and EPDM Standoffs

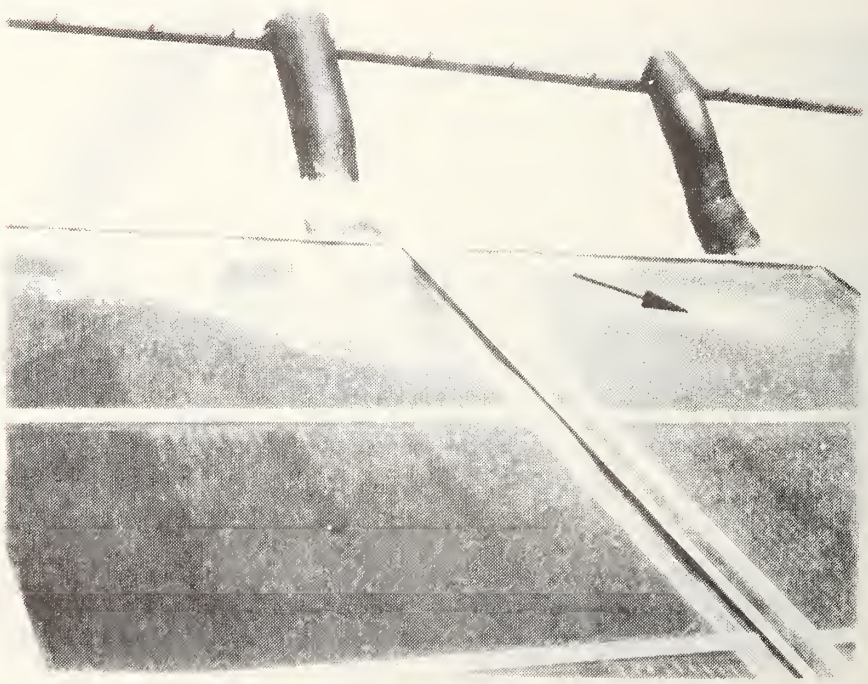
5. Instances of warped absorber plates were observed in several systems. Warpage was so extensive in several cases that the absorber plates came into physical contact with polymeric cover plates resulting in cover plate fogging (see fig. 2-12).

Figure 2-12. Absorber Plate and Cover Plate Warpage Resulting in Contact Between Absorber and Cover

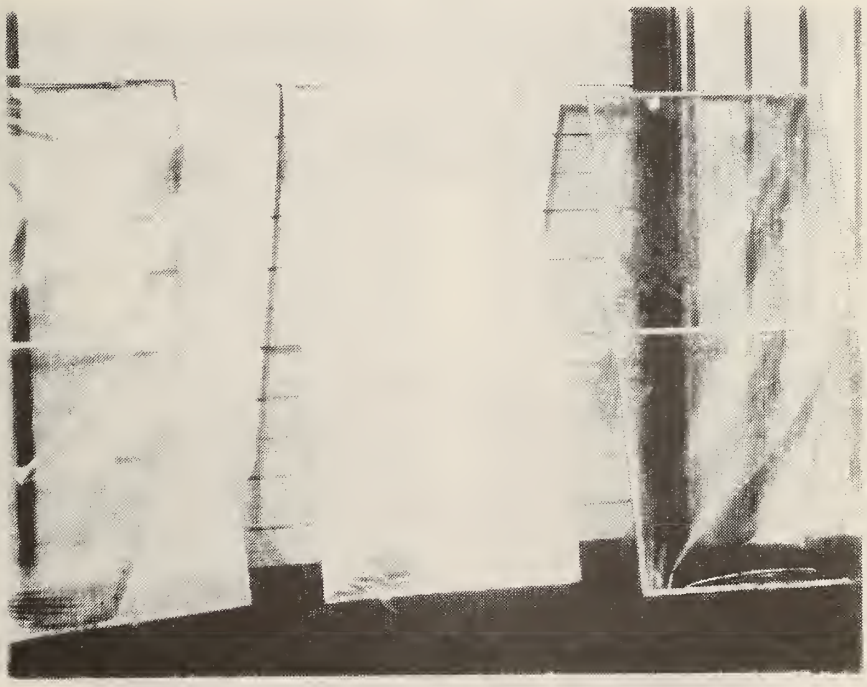
3. Embrittlement resulting in complete failure of all covers in a system using a double layer of thin film poly(vinyl fluoride) was observed. Collectors had been subjected to no-flow conditions for several months due to system failure (see fig. 2-14).

Figure 2-14. Embrittlement of Polyvinyl Fluoride Cover Plates after Exposure to Stagnation Conditions

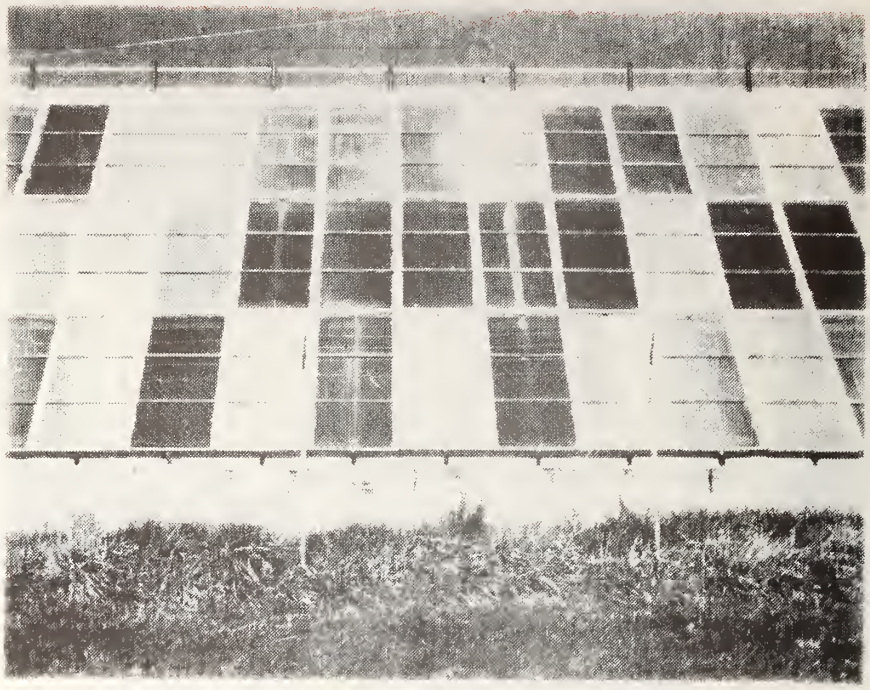
Figure 2-15. Color Variations of Anodized Aluminum Absorber

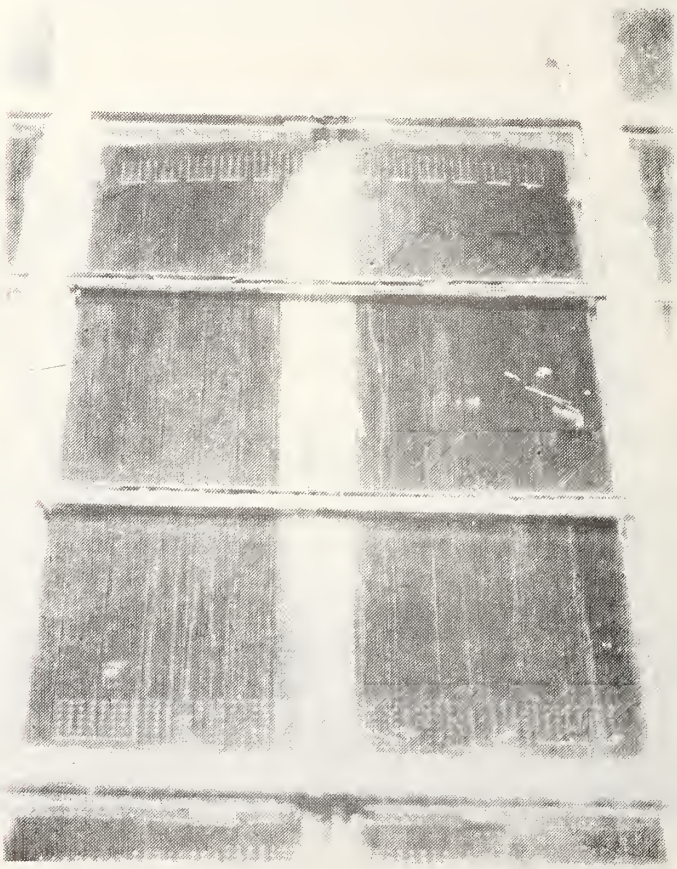
Figure 2-16. Effect of Transfer Fluid Flows, Due to Hose Failure, on the Color of Anodized Aluminum Absorber

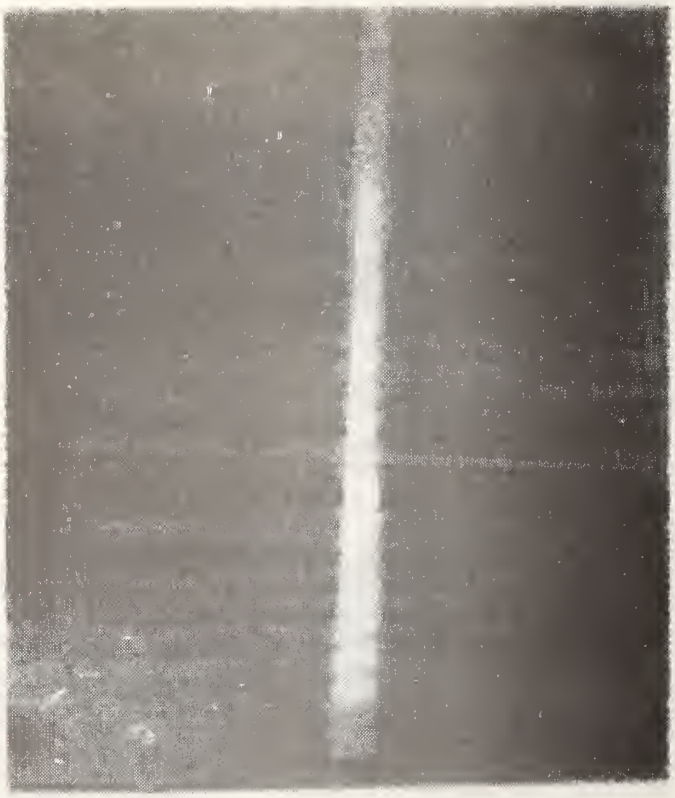
2. The insulation behind the absorber plates was visible through the cover plates in two of the systems inspected. This condition could result in deterioration of the insulation, excessive outgassing, and certainly reduces the absorber plate effective area. The cause may be attributed to either dimensional tolerances of the absorber plate, inadequate support or fastening of the plate to its supporting frame, thermal changes or creep occurring after installation, or poor workmanship during assembly (see fig. 2-20).

Figure 2-20. Gaps in Absorber Plate Resulting in Exposure of Insulation

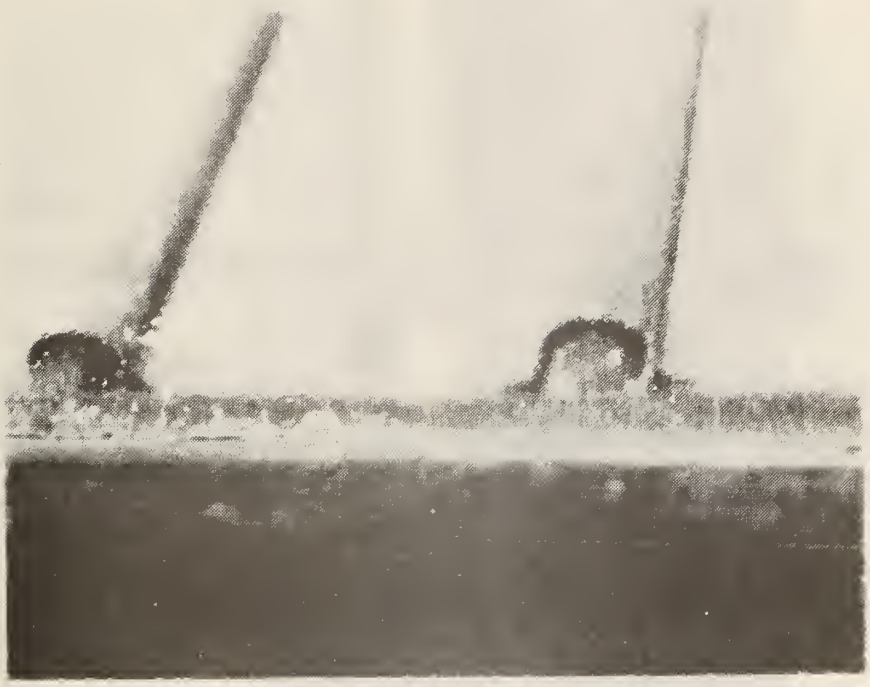
Figure 2-21. Failure of Joint Between Fluid Conduits and Absorber Plate

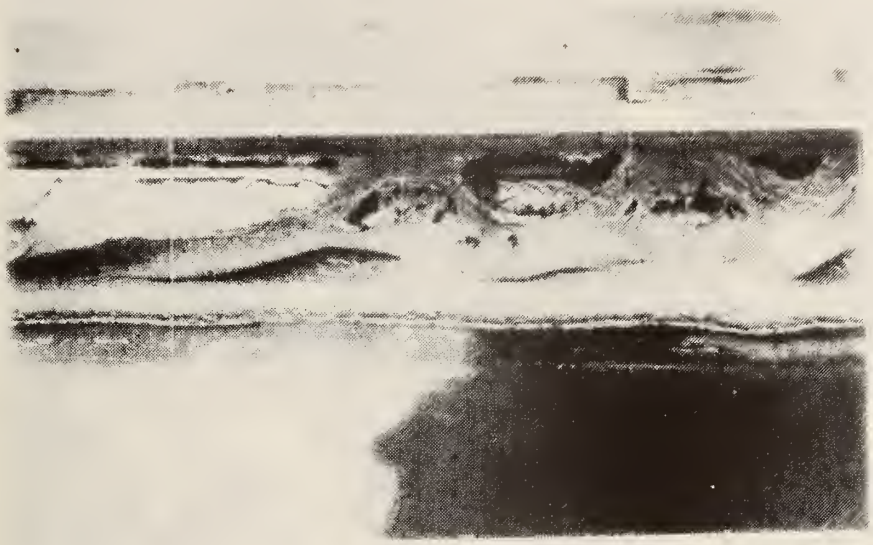
1. At one installation visited, the sealant used between the glass covers and the wood and aluminum collector enclosure was a major problem. The gray-colored (probably butyl) sealants used originally did not permanently seal the joints. The sealant between the inner cover and the wood enclosure was very brittle and lacked adhesion to the substrate. The sealant between the outer cover and either the wood enclosure or the aluminum cross tee was very brittle and had cracked and shrunk due to weather exposure. A number of the glass covers were undersized which meant that a joint of 3/4" to 1 1/2" had to be sealed. Thus not only was an inadequate sealant used but the joints were often impossible to seal with any sealant. The unsealed joints permitted water to penetrate into the collector interior (see figs. 2-9 and 2-25).

Figure 2-25. Failure of Sealant Between Tempered Glass Covers and Aluminum Extrusion

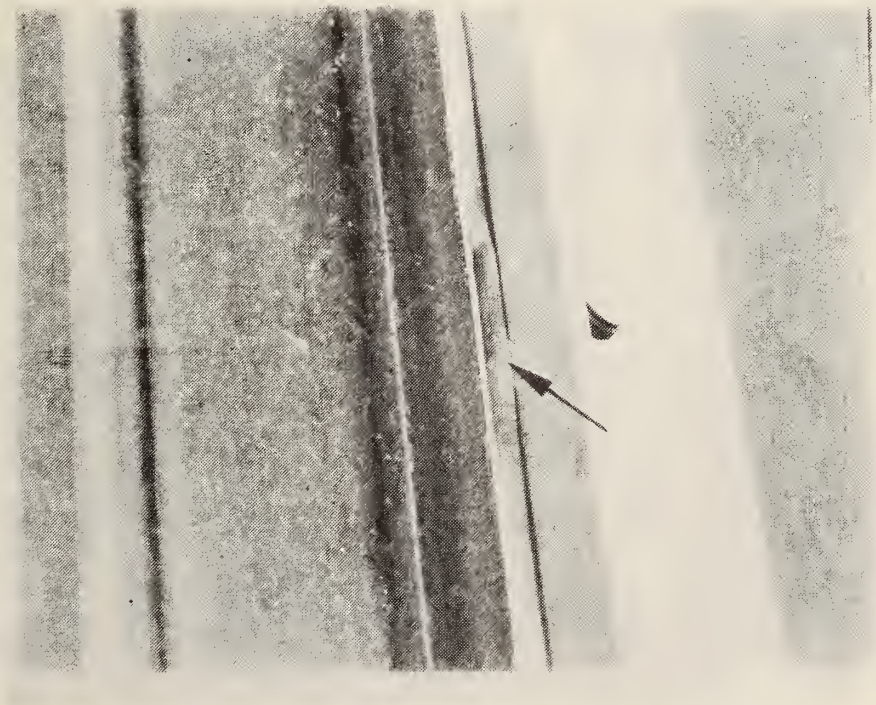
3. One site visited used a silicone sealant between the outer cover plate and the aluminum retaining frame. Workmanship was excellent but potential problems may occur due to a discoloration of the sealant adjacent to the attachment bolts. The discoloration observed may be an indication of material degradation. Apparently a "hot spot" was created by the attachment bolts which is subjecting the sealant to deteriorating elevated temperatures (see fig. 2-26).

Figure 2-26. Discoloration of Silicone Seals

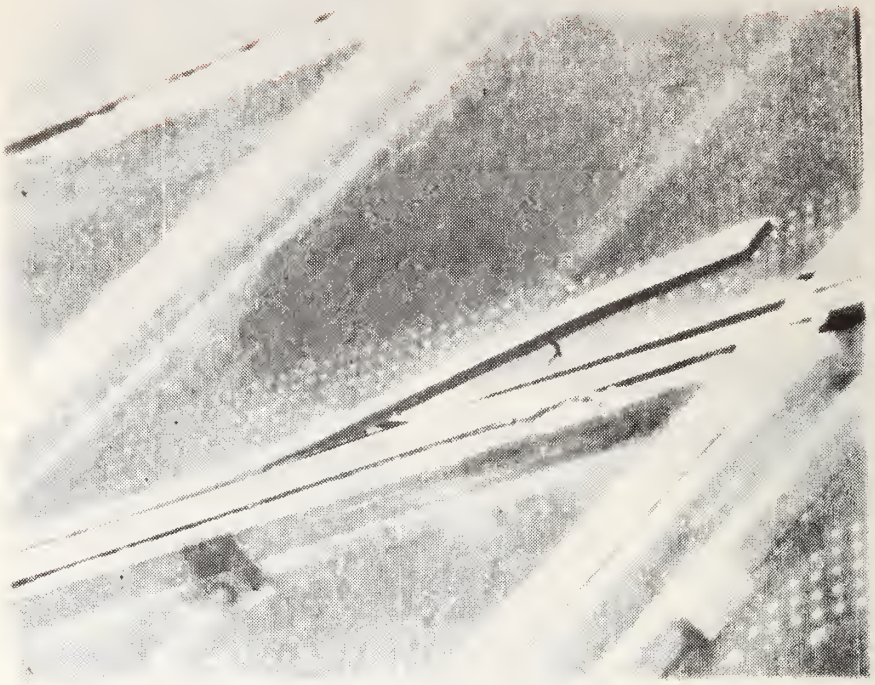
2. In one case, the collectors were made of wooden restraining frames with plywood backing. The painted wood collector frames had deteriorated because the paint coatings had peeled and cracked exposing the wood to the elements. The surface condition of the painted wood in the interior of the collector was worse than that of the exterior membranes. The plywood backing had not been painted and was deteriorating and delaminating due to moisture penetration even though these collector backs were not subjected to direct weathering. The condition of the wood indicated that it will probably require major repair or replacement within 2-3 years (see fig. 2-27).

Figure 2-27. Deterioration of Wooden Restraining Frames

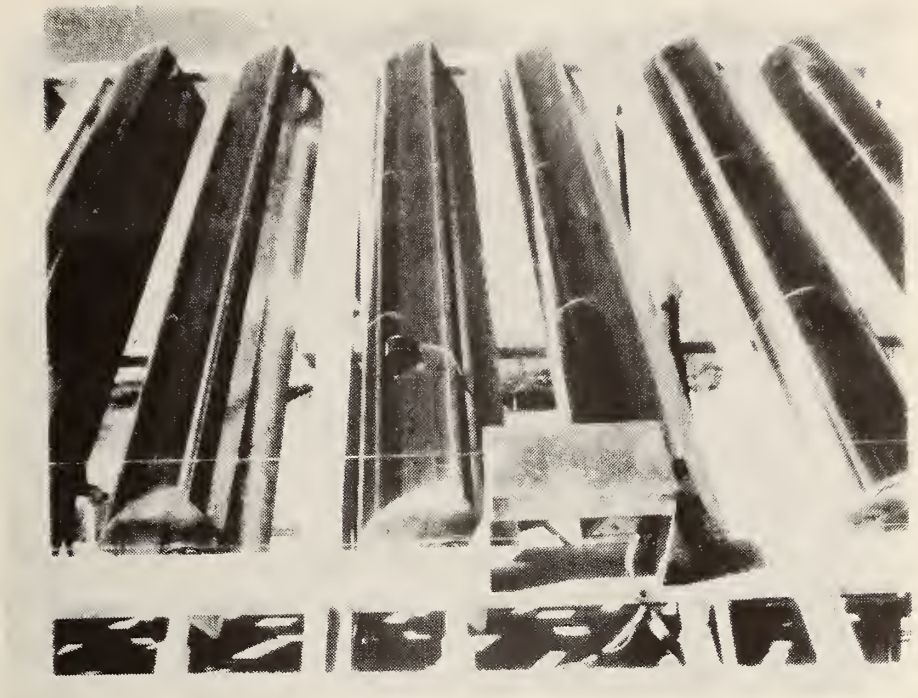
Figure 2-29. Tracking Collectors

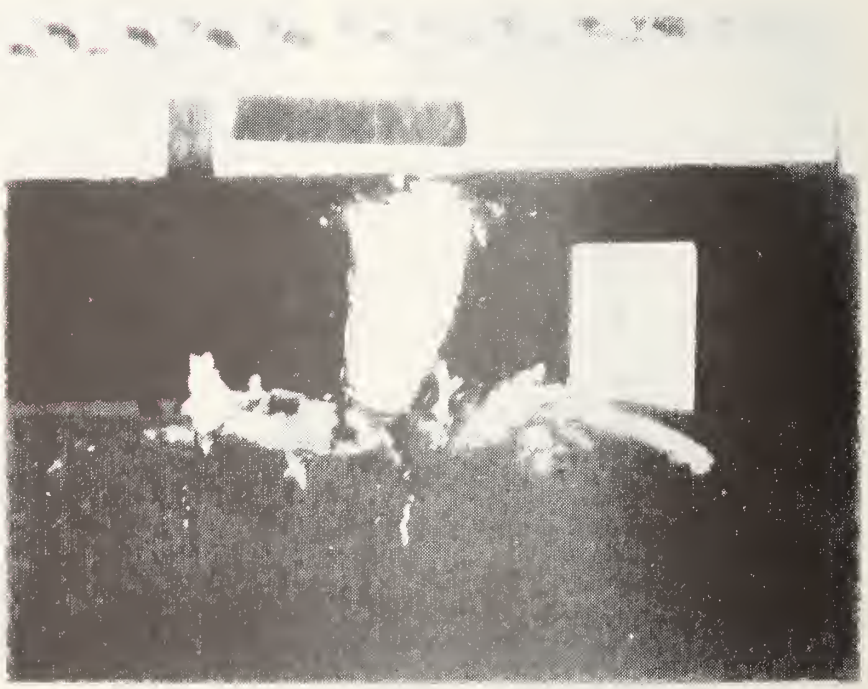
Figure 2-32. Field Expedient Repair of Flexible Coupling Hose

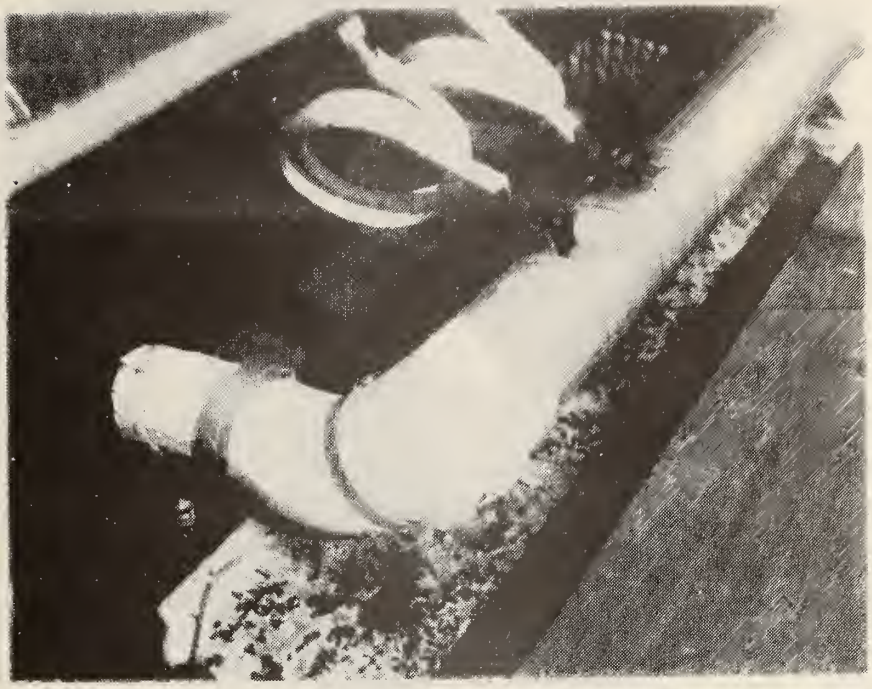
Figure 2-33. Copper Coil Replacement of Flexible Hoses

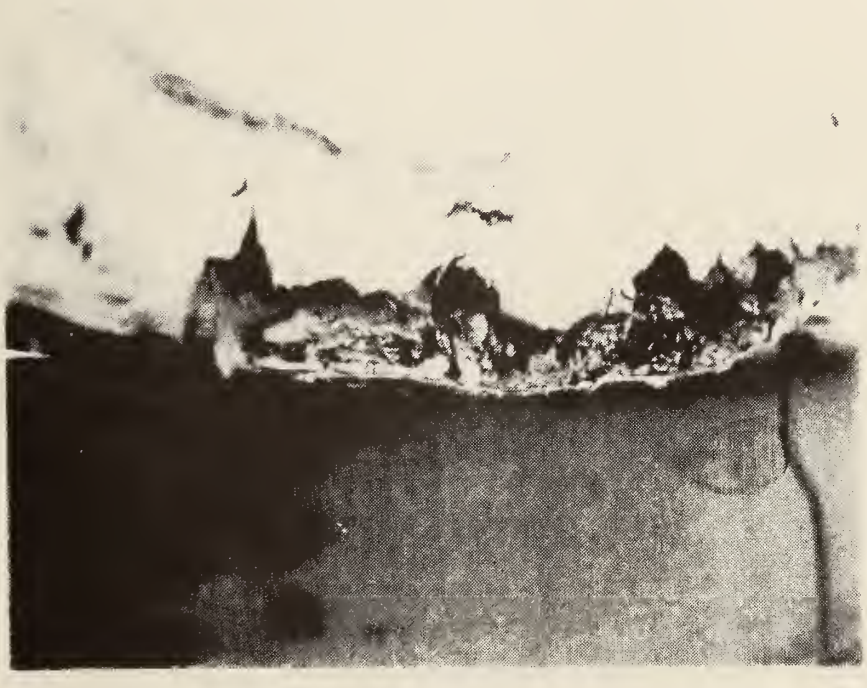
The other two storage problems had to do with the tank insulation. In one case a liquid leak from a tank connection resulted in the deterioration of vermiculite plaster insulation used on the ends of the cylindrical roof mounted tank (see fig. 2-38). In the other case, an insufficient amount of insulation was used on three buried tanks resulting in excessive heat losses. This was evidenced by the fact that the earth cover did not support the growth of vegetation. This heat loss was also substantiated by the rapid drying of the area above the buried tanks after a rain storm when compared to adjacent areas.

Figure 2-38. Deterioration of Vermiculite Plaster Storage Tank Insulation
